Detection of the onset of galling in strip reduction testing using acoustic emission

Marcel Moghadam, PhD-student

DTU Mekanik
 Institut for Mekanisk Teknologi

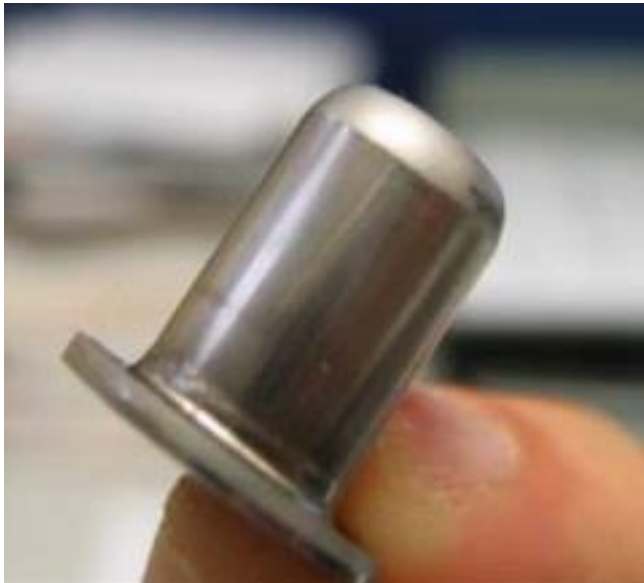
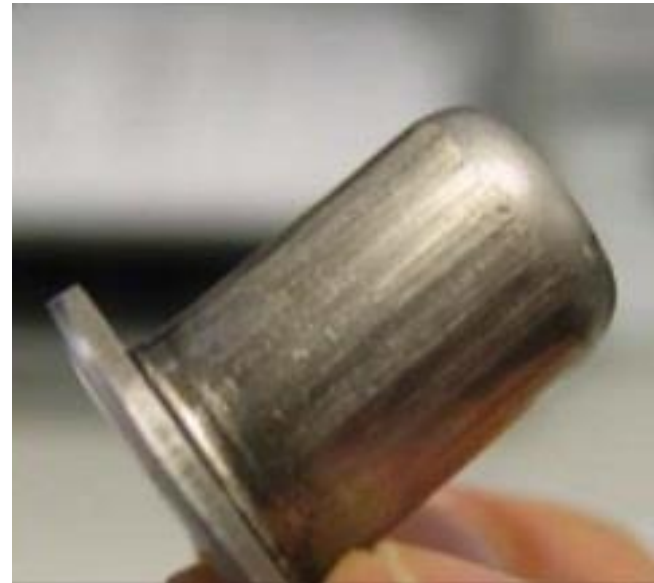
Fig. 1. Deep drawn component, (a) good surface quality, (b) poor quality due to galling

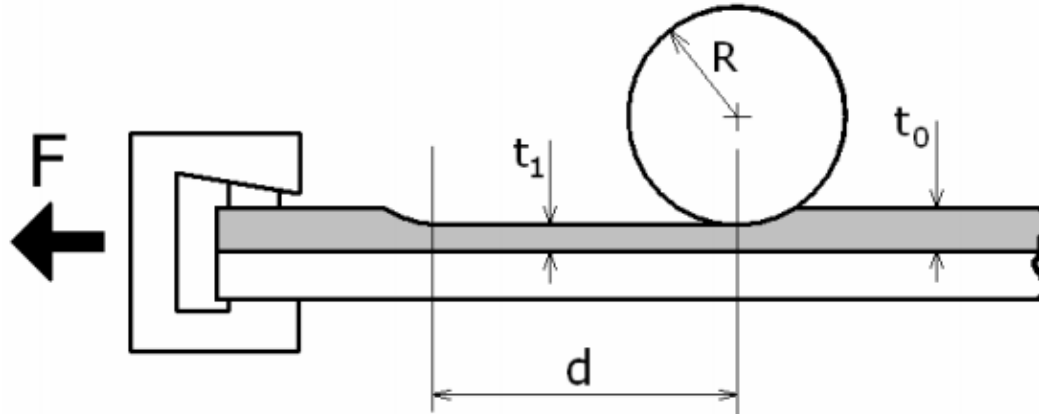
Strip reduction testing

Tool: Ø15 DIN W. no.13344 PM

Ra 0,02

Strip material: 304L stainless steel, 20% reduction

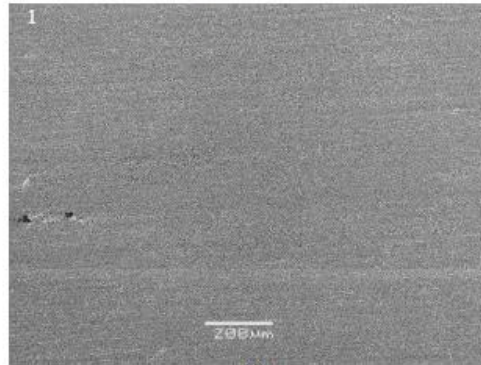
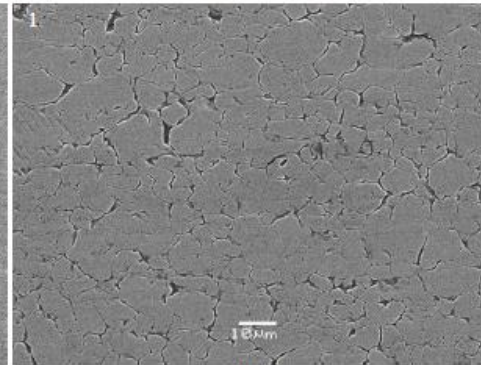
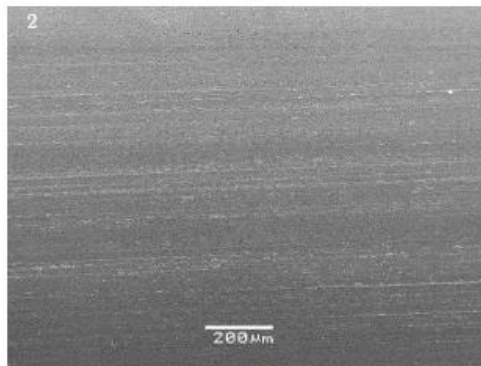
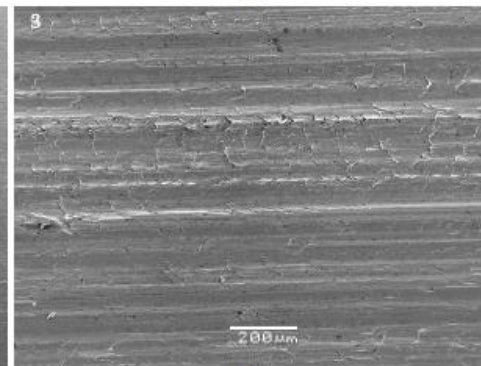
Surface roughness upon strip reduction

(a)

(b)

(c)

(d)

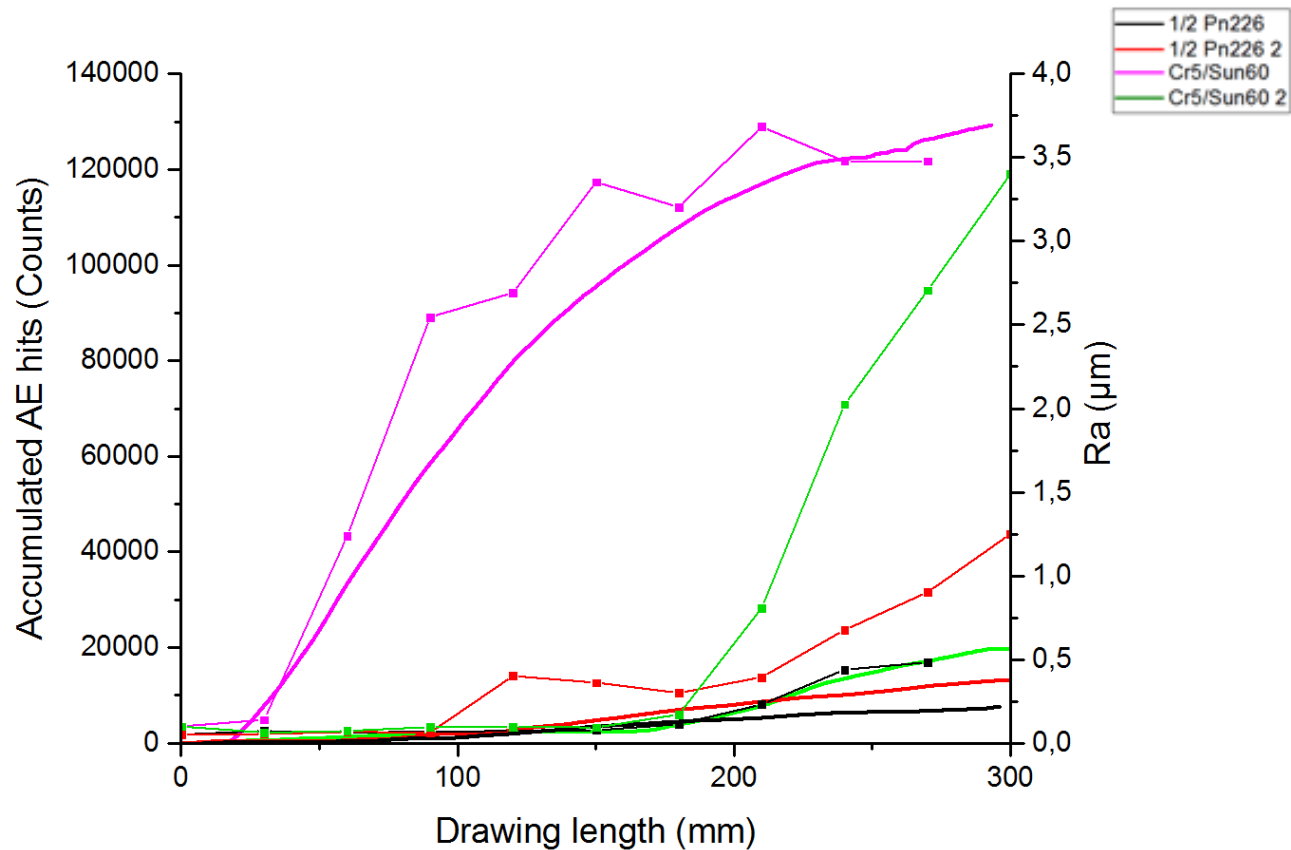
AE hits and developed surface roughness

- Acoustic emission can be applied as an indirect, online monitoring technique for detection of the occurrence of galling.
- A correlation is found between the RMS signal and the severity of the wear, indicating the frictional conditions in the tool/workpiece interface.

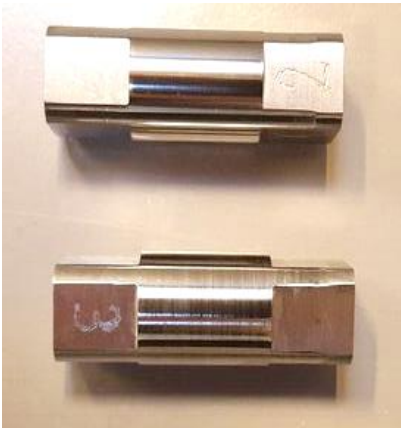
Ra 0,08

Ra 0,35
TDN 81
